**REDUCTION OF**

**RADIOLOGICAL**

**CONSEQUENCES**

Title	The Steam Generator Tube Rupture accident (SGTR)
Speaker:	François Parmentier
Affiliation:	Bel V
Event:	R2CA Summer School
When:	4-6 July 2023

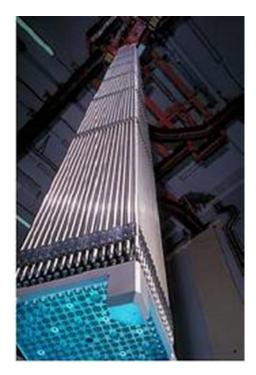
157 assemblies in a PWR core
